# Cooke's Hollow

## Feasibility Study and Preliminary Design Report

Arlington, Massachusetts

August 2023

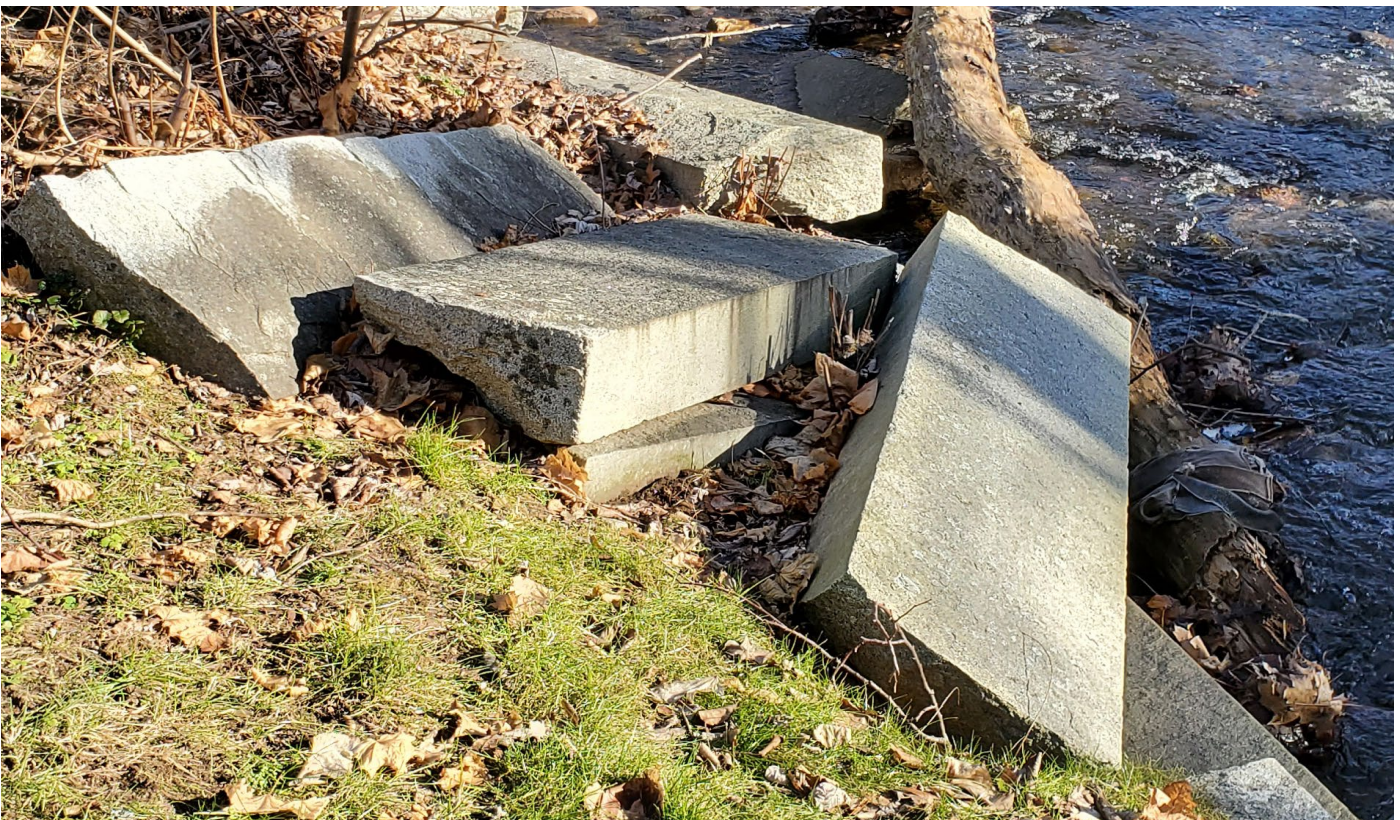
8 Failing Granite Curb Edge

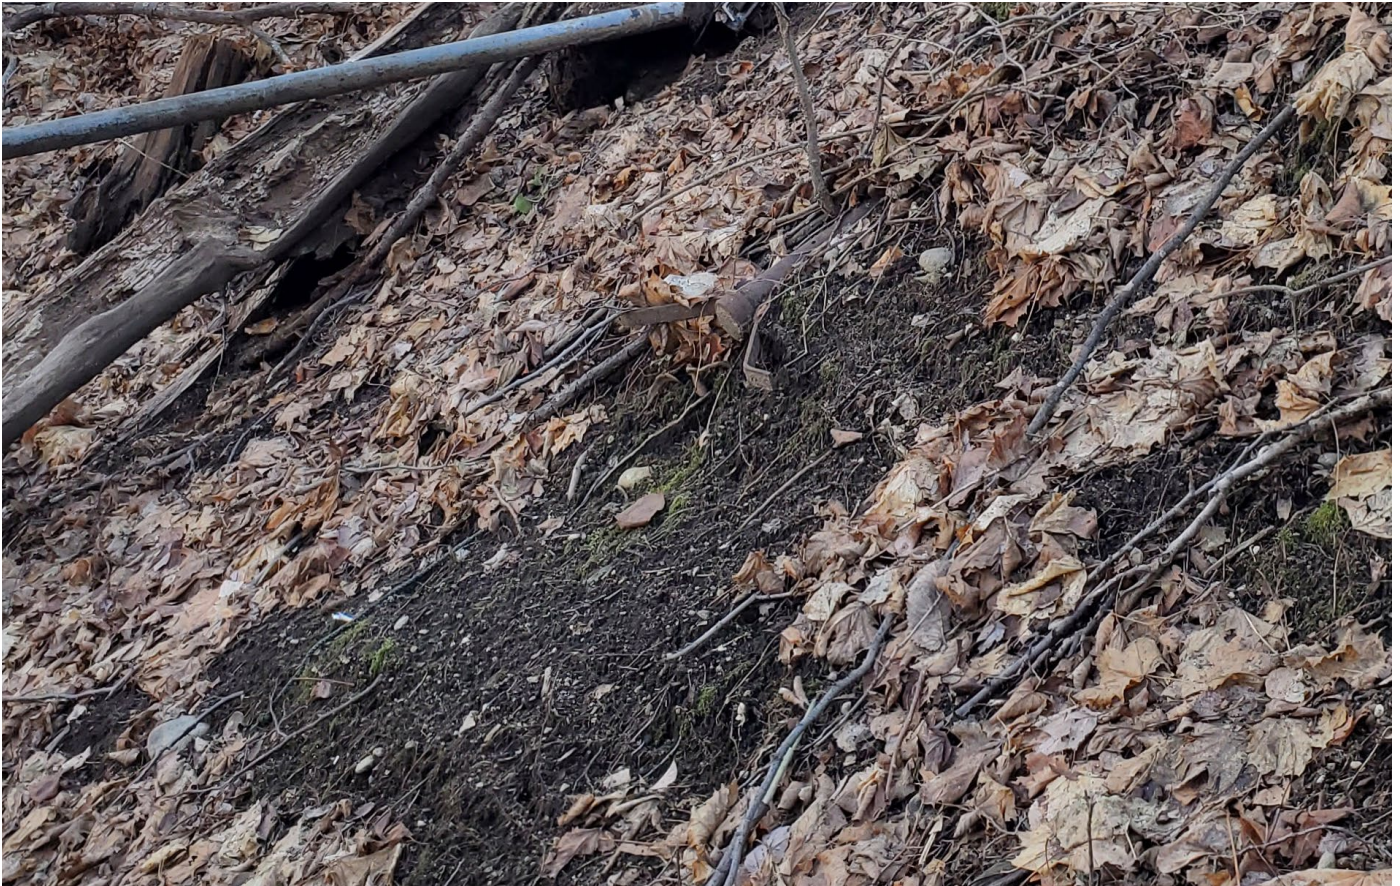
3 Eroding Conditions on the Southern Slope

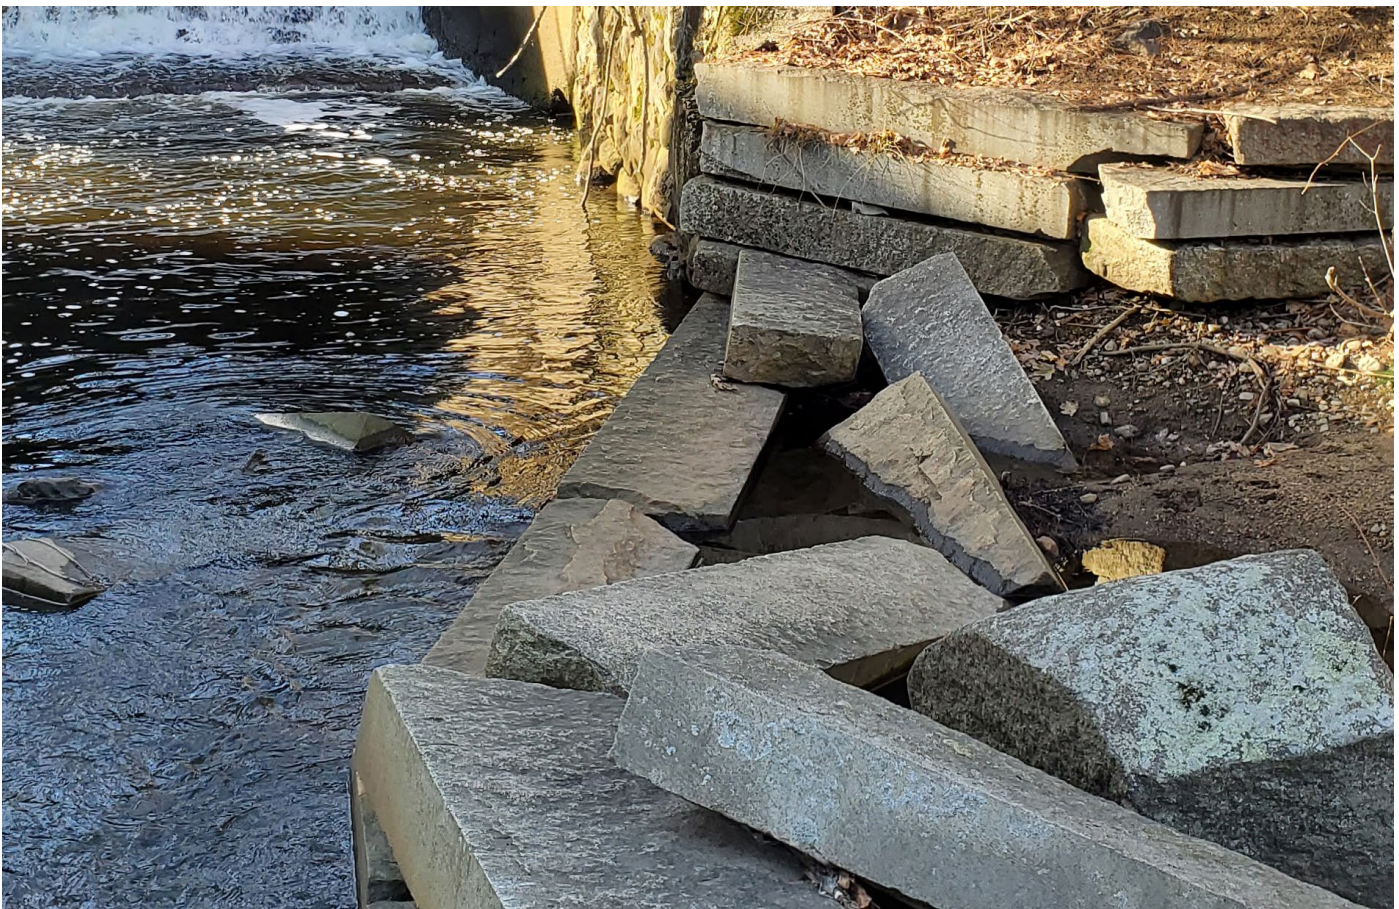
8 Failing Granite Curb Edge (North Side Near Falls)

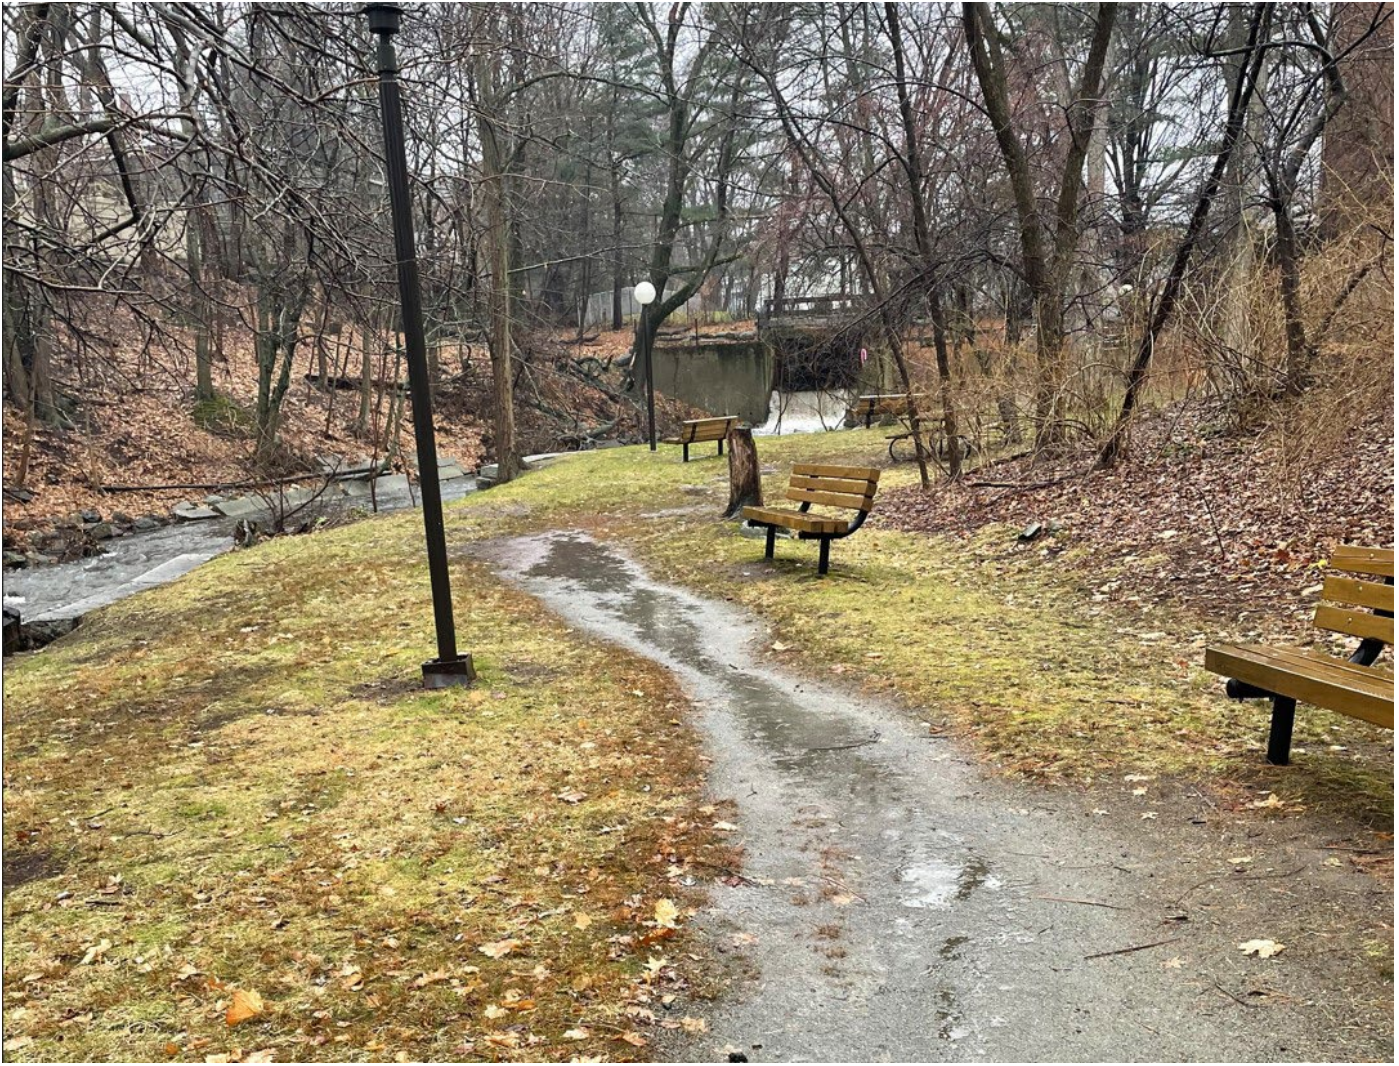
11 Surface Runoff Collecting on Stone Dust Pathway

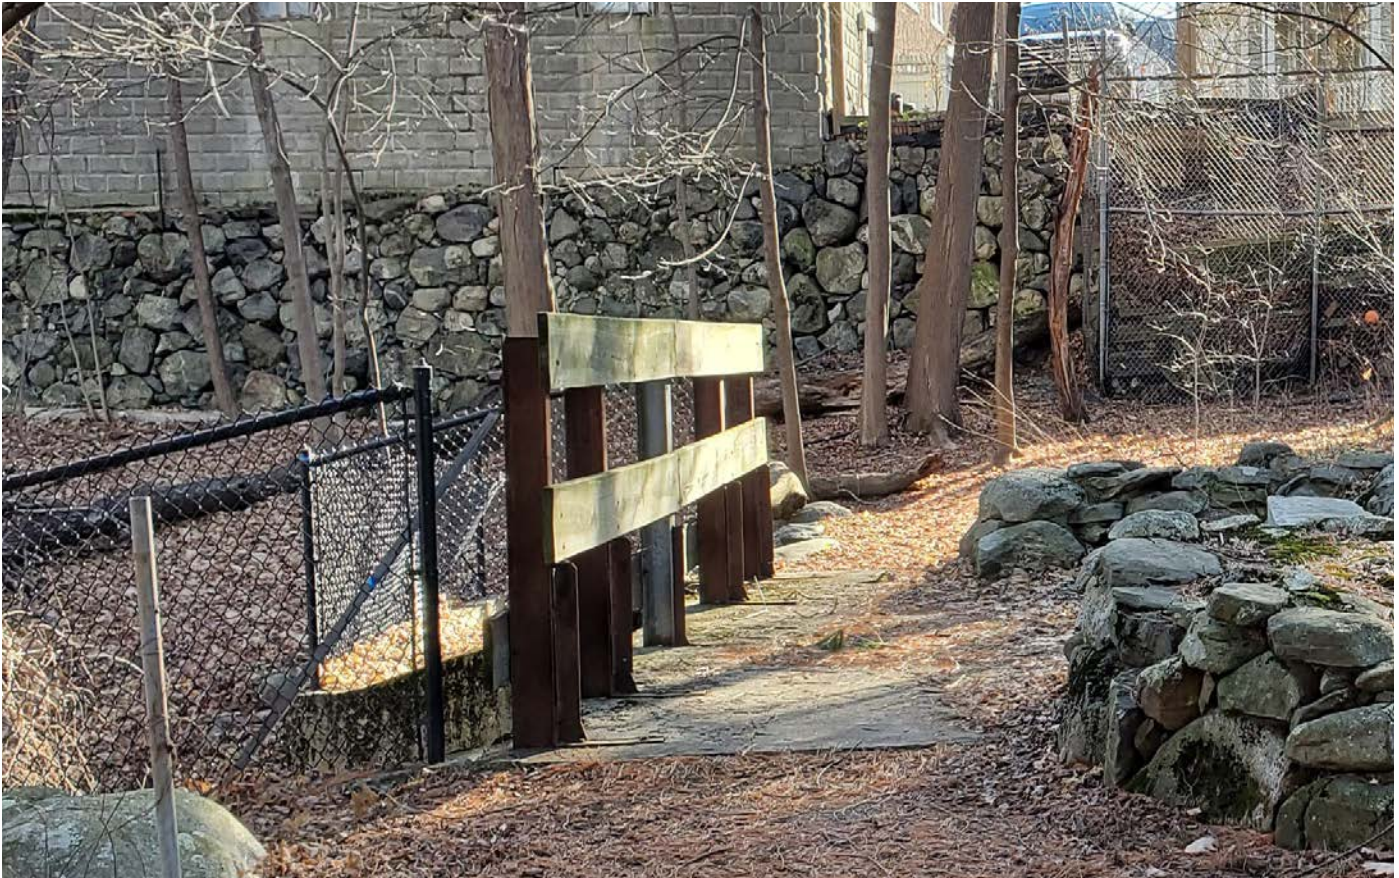
2 Unsafe Steel and Wood Guardrail Above Falls

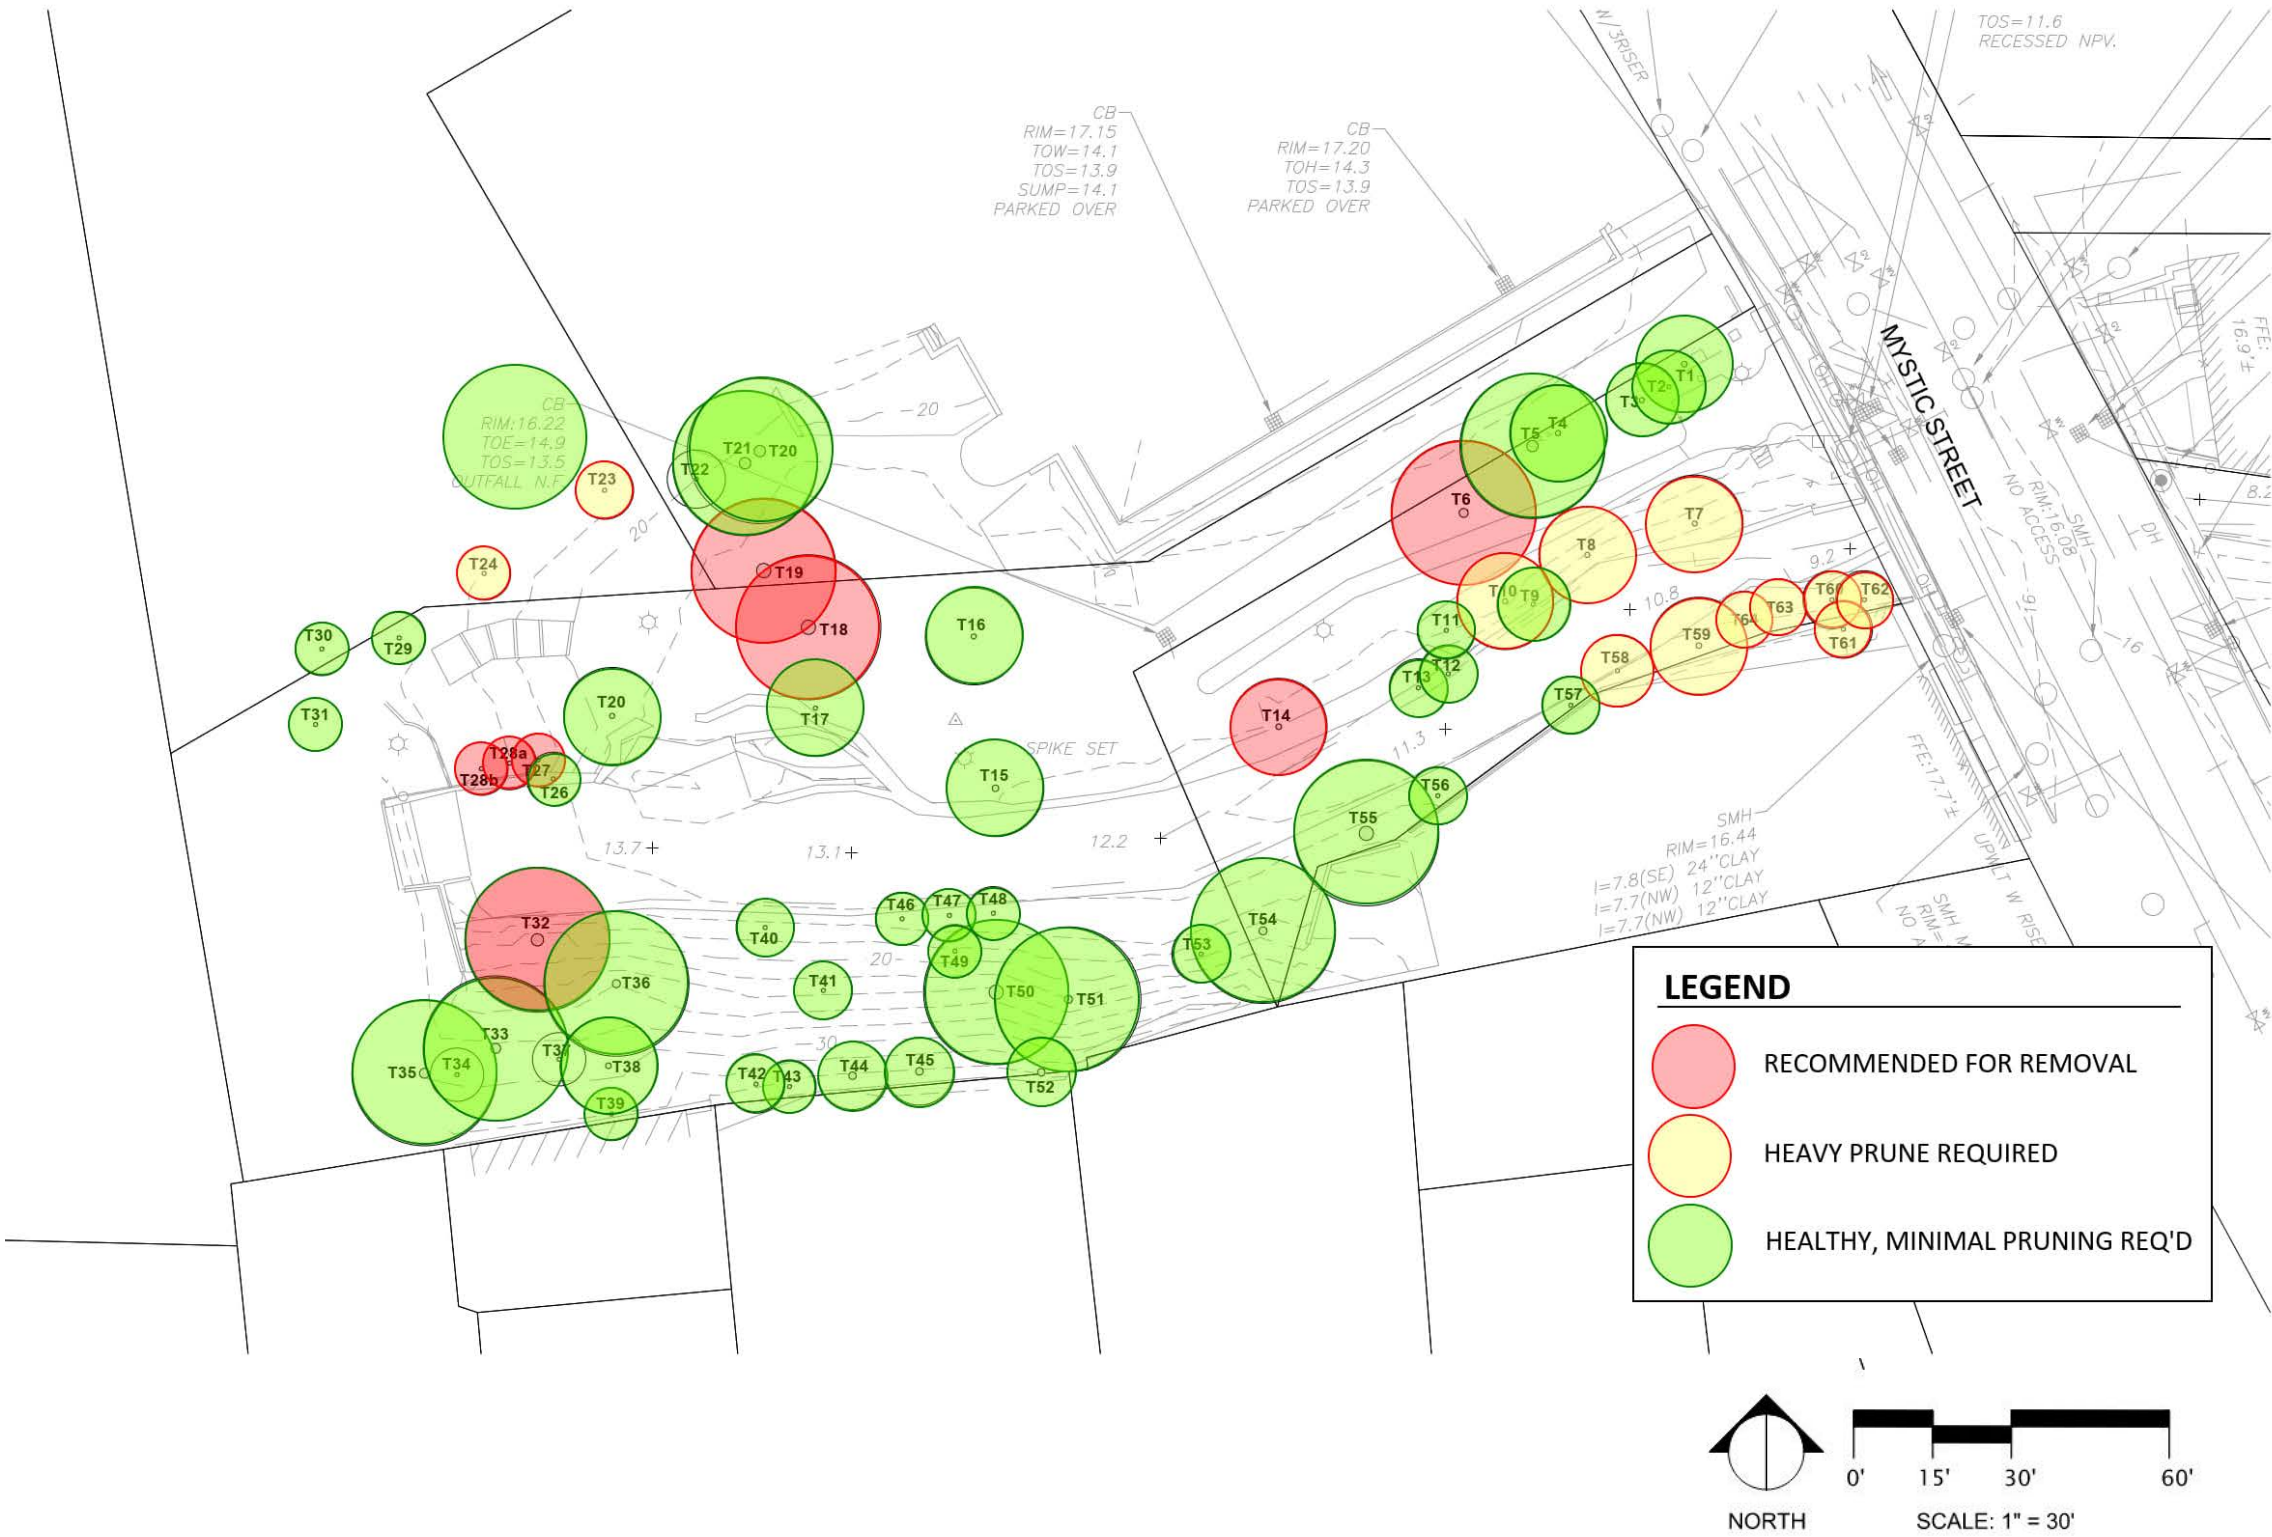
Several factors were considered for the condition of each tree, including root characteristics, branch structure; trunk, canopy, and foliage condition as well as the presence of pests. The condition of each inventoried tree could be broken down as follows: (R) Remove, (P) Prune, (M) Monitor, (H) Healthy. See attached location diagram and assessment table for further detail.

Hatch recommends seven (7) hazardous trees be removed due to public safety concerns. The Town arborist should review and assess these trees (immediate action)

These trees are calculated to be a low or moderate risk and should be pruned (immediate action)

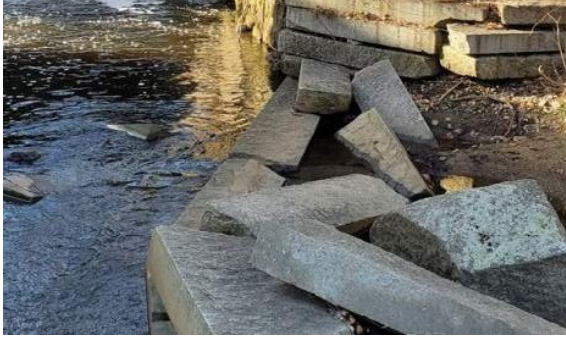
8 Stacked Granite Edge In Need of Repair
